APPLICATION REPORT

Detmaster PRT Web Inspection System on a Board Machine

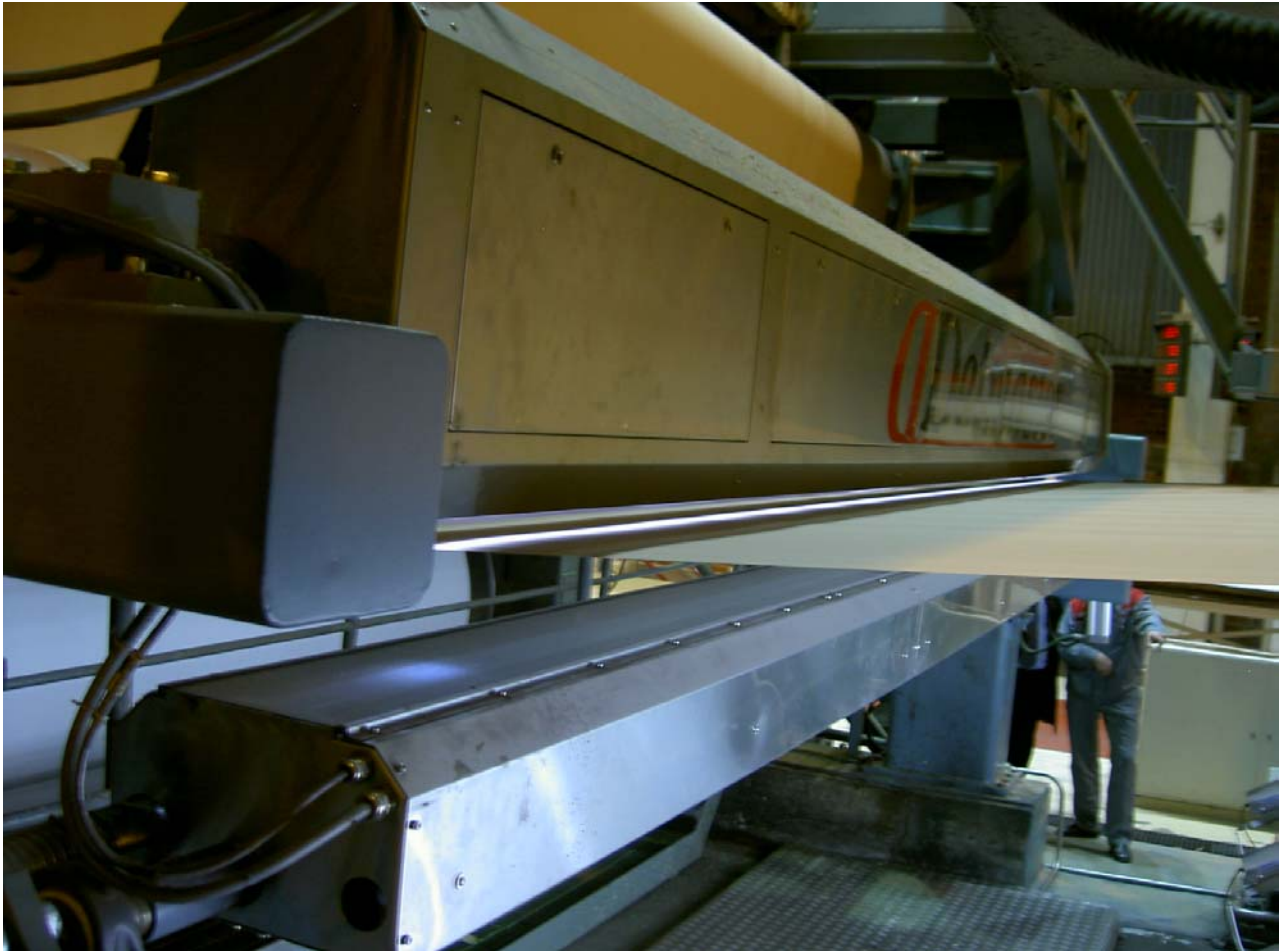
Detmaster 5200 PRT system installed at Stora Enso Imatra mills' board machine No. 5.

In October 2005, Detmaster 5200 PRT Web Inspection System installation, delivered by SR-Instruments Oy, was completed at Stora Enso Imatra mill's board machine No. 5. The board machine comprises an online coating station and produces both coated and uncoated 3-ply board grades. The web width is 5100 mm at the pope reel of the board machine and the maximum line speed is 600 m/minute.
