Detmaster

8600 PR System

at Stora Enso Oulu Mill

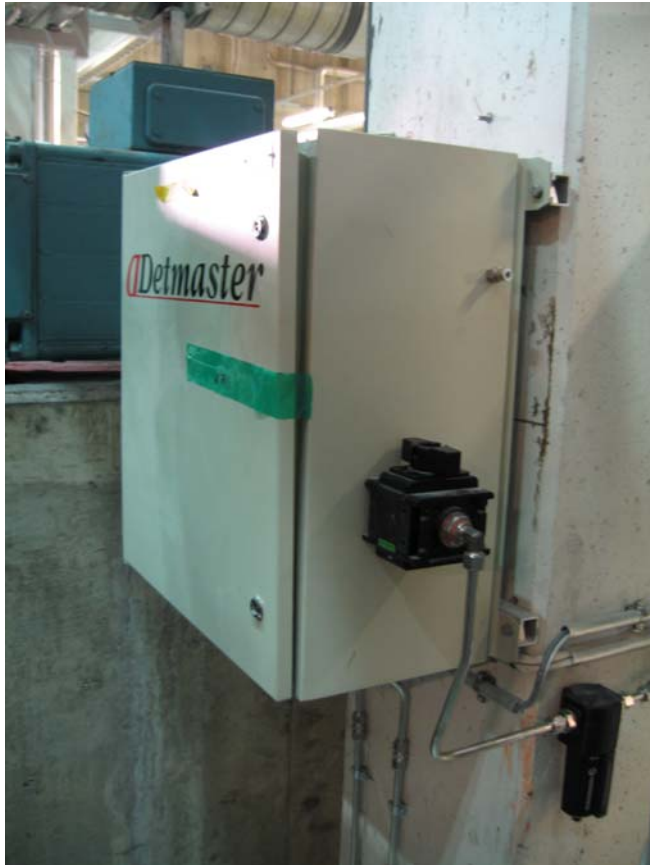
Pneumatics cabinet including safety valve through which compressed air is fed into the cabinet. The safety valve guarantees that the system could be deflated pressureless when needed.

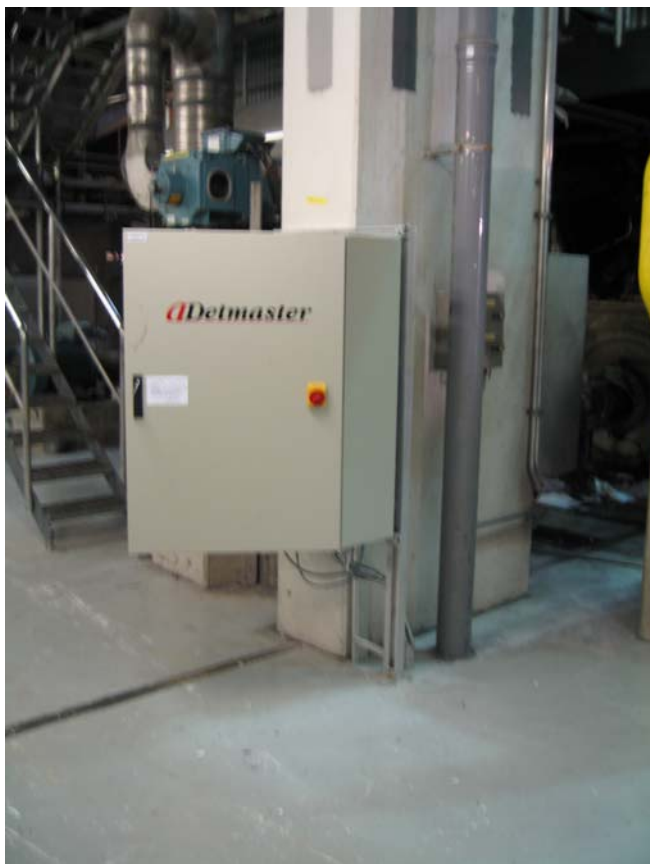
Electronics cabinet including main switch (red switch on the door) and cabling emerging from the bottom of the cabinet.

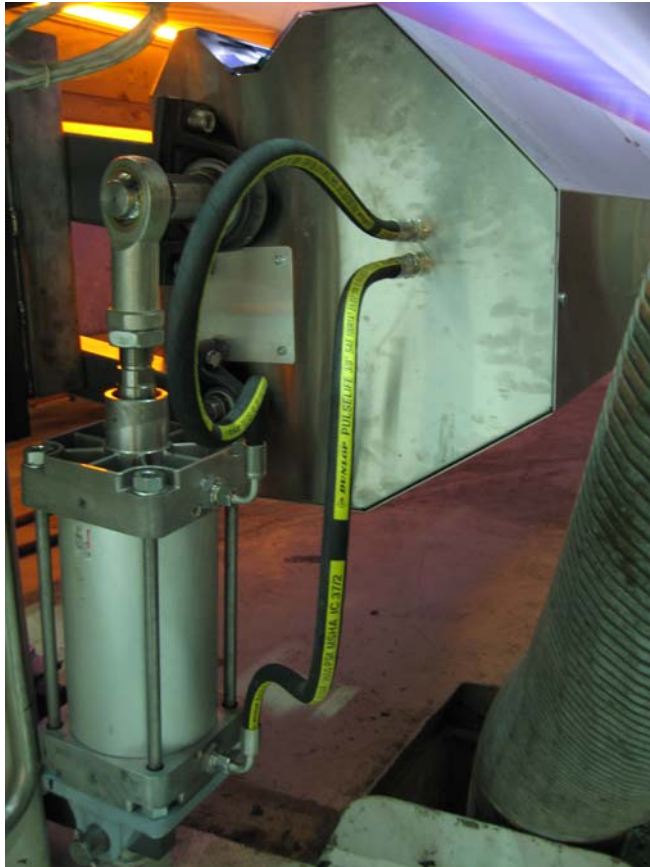
Inspection beam mechanics at the operator side. Pneumatics tubes emerge from the beam and are connected into the pneumatics cylinders, which enable up / down movement of the inspection beam e.g. in order to facilitate paper tail threading.

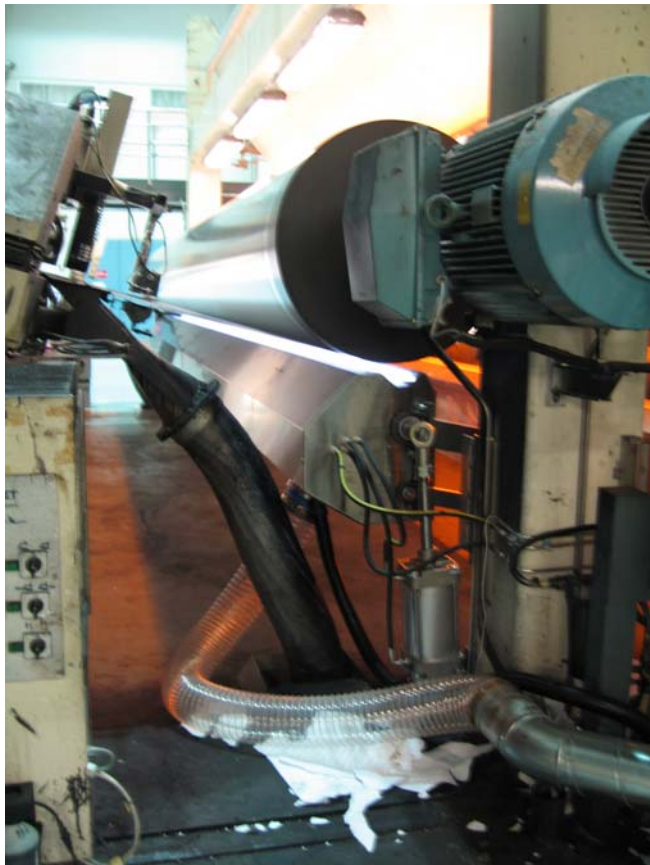
Inspection beam (below the roll) and its pneumatics cylinder as well as low pressure (cooling) air pipes seen from the drive side.
